# TEST REPORT

Test Report No: NST/GW131661-2

Sample Name: Brass Cable Glandsun Testing

### Degrees of protection provided by enclosure(IP code)

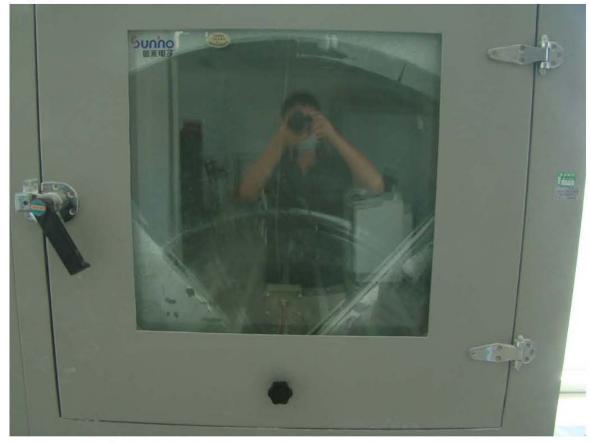
### 13 Tests for protection against solid foreign objects indicated by the first characteristic numeral Testing description: Standard: IEC60529:2001 IP code: **IP68** IP6X: The object is freely suspended in the dust chamber, lasted 8 Operating conhours with the depression not exceed 2KPa, the pressure inside the enclosure is maintained below the surrounding atmospheric pressure ditions: by a vaccum pump. Phenomenon( IP6X: No deposit of dust is observable inside the sample after the test): at the end of the test. So the protection is satisfactory. Photograph:

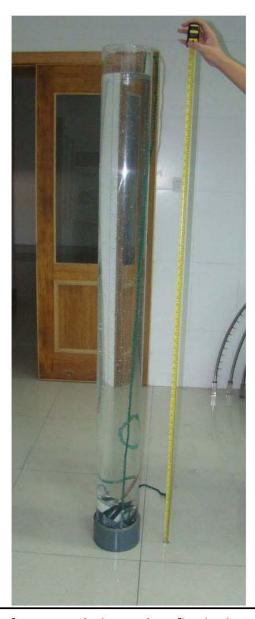
# 14 Tests for protection against water indicated by the second characteristic numeral Testing description: Standard: IEC60529:2001 IP code IP68 Operating conditions: IPX8: The lowest point of enclosures is located 1.5m below the surface of the water, the duration of the test is 35min; the water temperature does not differ form that of the equipment by more than 5K. Phenomenon( after the test): IPX8: No water entered.

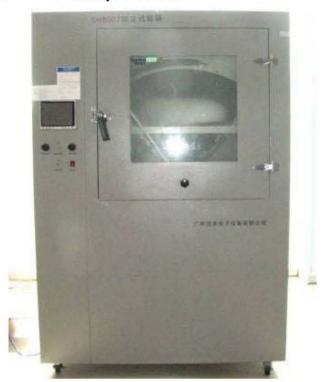
Fig.1 Dust chamber

1. Test equipments: Dust chamber (see Fig. 1), Immersiom test device(see Fig. 2),
